Reach 11 – Shoal Point to Wellers Bay

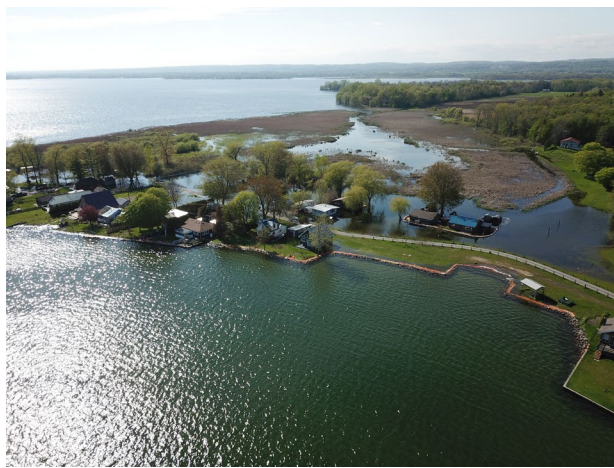
Flood Prone Properties, Evergreen Lane (May 2019)

- Evergreen Lane/Shoal: existing development requires floodproofing at the community scale, including ensuring safe ingress/egress and functioning private septic systems, or managed re-alignment/retreat for the entire community.
- Monitor and maintain existing shoreline protection structures throughout reach.
- Monitor shoreline erosion at Clifford Street and Barcovan Beach Road where shoreline is in proximity to bluff crest and within the erosion hazard setback.
- Upgrade roads that are below the 100-year flood hazard limit including Barcovan Beach Road at the entrance to Wellers Bay.

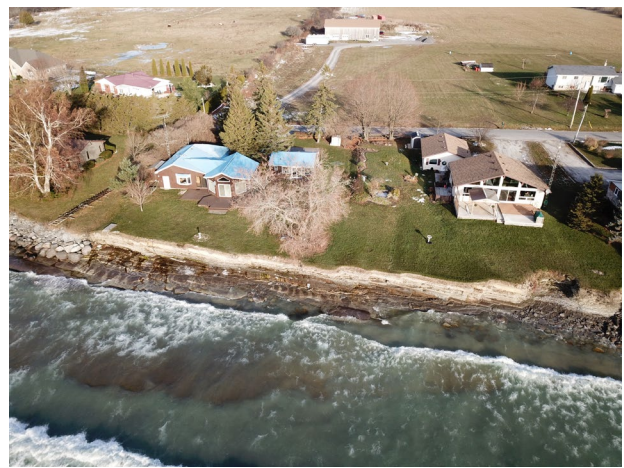
Exposed Bedrock Shoreline, Barcovan Beach Road (November 2018)
