Reach 12 – Wellers Bay and Barrier Beach

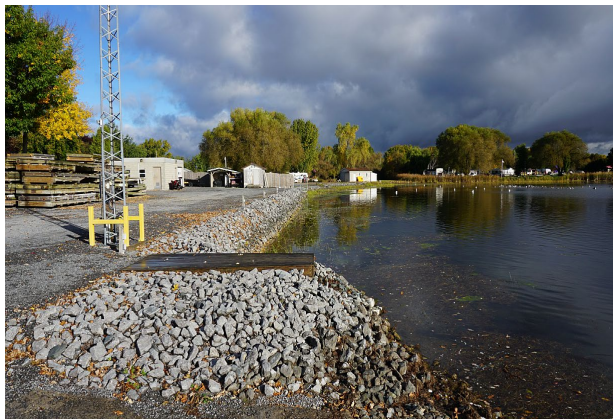
Armoured Shoreline at Trailer Park

- Reach 12 is 22% armoured, 78% natural.
- Shoreline protection is limited to the north shore of the entrance to Wellers Bay and the east facing shoreline along Carter Road, which is primarily occupied by private cottages and trailer parks.
- Most shoreline armoured is ad-hoc quarried stone or boulder revetments and concrete seawalls. Most structures are in poor to moderate condition; however, this is primarily due to age and not wave or ice related damage. Protection structures are exposed to little wave action.
- The Wellers Bay barrier beach complex is anchored by a 220 m long rock jetty on the east side of the Wellers Bay navigation channel. The jetty is in a state of deterioration and requires upgrades to be effective in mitigating sand and wave transmission into the navigation channel.
- Tolerance for additional shoreline armoured (**low/medium/high**):

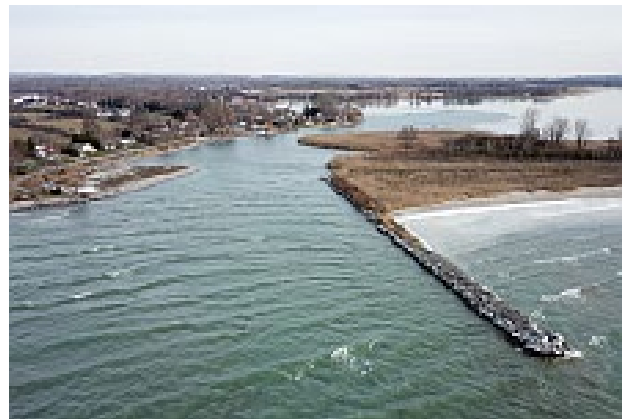
Entrance to Wellers Bay

- Reach Length = approximately 3 km.
- Low energy shoreline sheltered from Lake Ontario wave action.
- Mixture of natural shoreline with coastal wetlands and high-density development.
- Single rock jetty protects the navigation channel to the bay. Sediment that accumulates in the channel is dry-docked and disposed upland.
- Wellers Bay and the barrier islands were established as a National Wildlife Area in 1978 for the rare coastal habitats including natural beach, sand dunes, wetlands, and deciduous forest. The habitat is used by migratory waterfowl, nesting shore birds (see adjacent Belted Kingfisher), and several federally listed species at risk.

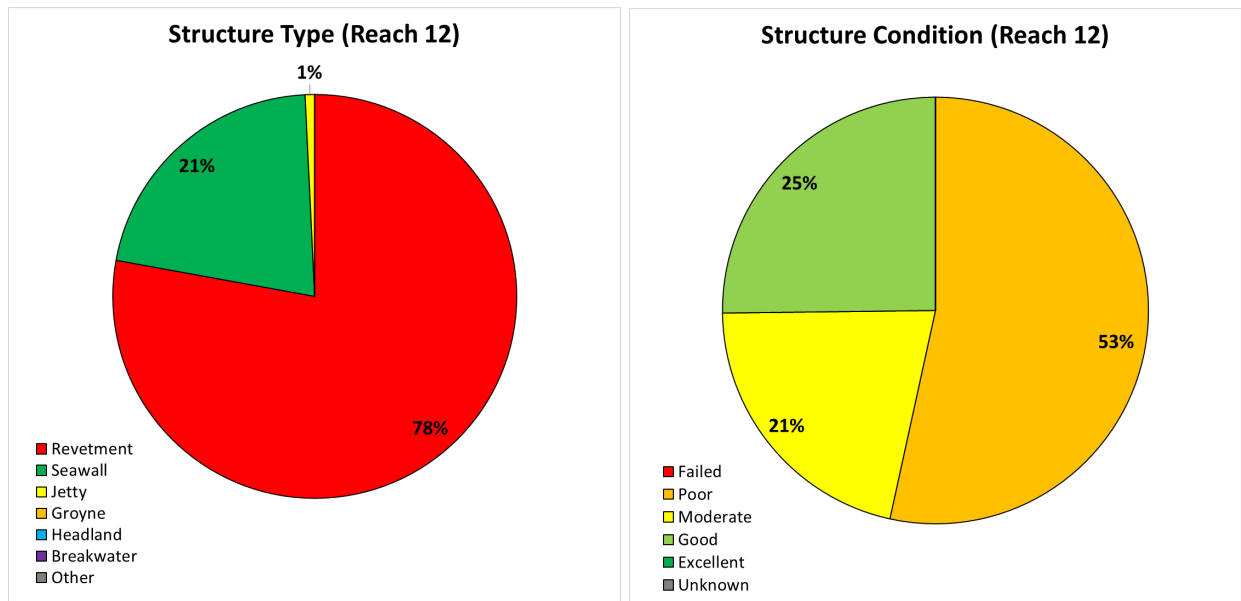
- Sample statistics (for armoured portion of shoreline):

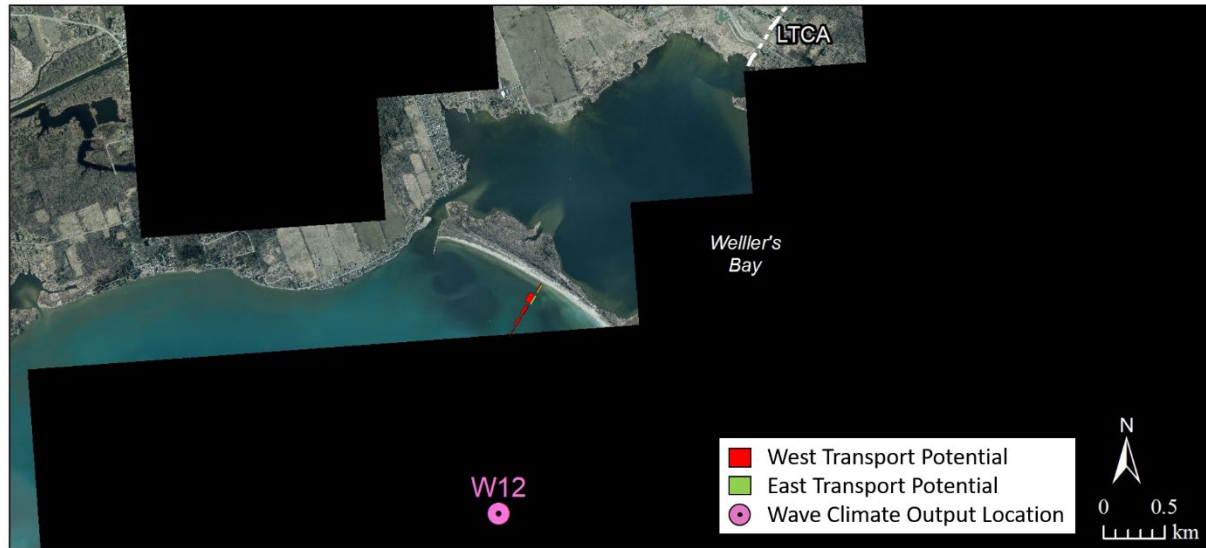
- Sediment transport is limited to the exposed portions of Reach 12 such as the Wellers Bay barrier beach complex and navigation channel.
- Sediment is driven into and deposited within the Wellers Bay navigation channel from Barcovan Beach Road to the west (Reach 11).
- The net sediment transport potential along the exposed portions of the Wellers Bay barrier beach complex is from southeast to northwest (towards the Wellers Bay navigation channel). The potential transport rate is on the order of 10,000 m³/year. This

material moves along the beach face and is deposited against the Wellers Bay navigation channel jetty or transmitted into the navigation channel itself.
