Reach 9 – Ogden Point to Presqu'ile Provincial Park

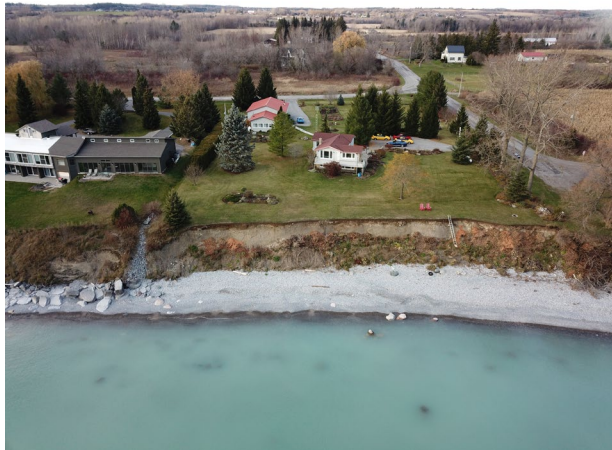
Eroding Bluff Shoreline, Victoria Beach

- Reach Length = approximately 16.4 km.
- Ogden Point to Presqu'ile Provincial Park is the final littoral sub-cell that was once part of a large littoral cell that extended from East Point Park in Scarborough to Presqu'ile Provincial Park (Reinders, 1988).
- The eroding bluff shoreline east of Ogden Point features shoestring development along the bluff crest.
- The central portion of the reach is primarily agricultural lands and natural areas.
- The shoestring development begins again in Popham Bay and extends to the northwest boundary of the Provincial Park.
- The Provincial Park is a major sediment sink as evident by the successive beach ridges that have formed over time and now connected to Gull Island.

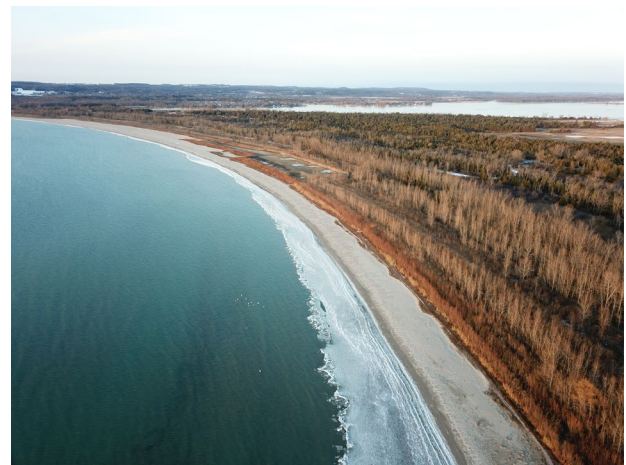
Presqu'ile Beach, Presqu'ile Prov. Park

- The primary depositional area for the reach is Presqu'ile Beach, which historically received much of the west to east transport along the entire project shoreline before the shoreline became fragmented into several sub-cells due to human development.
- The Popham Bay shoreline immediately west of Presqu'ile Beach is characterized by shallow bedrock shelves, which typically only house cobble and shingle beaches comprised of eroded bedrock material. Smaller silts and sands appear to typically move further offshore until they are deposited at Presqu'ile Beach.

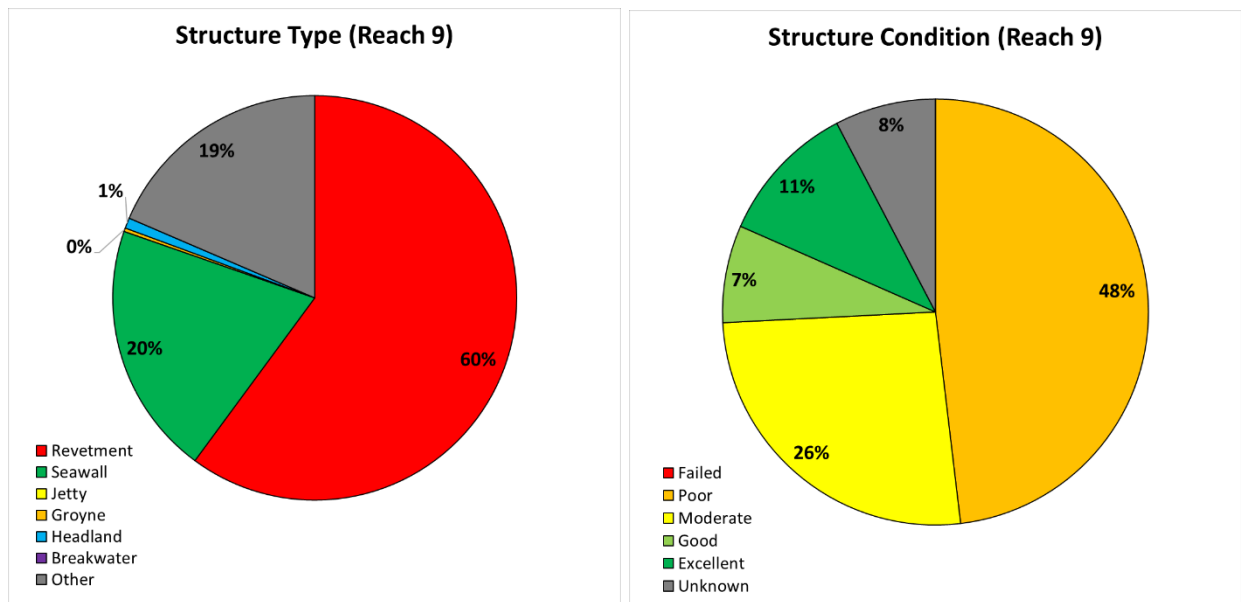
- Sample statistics (for armoured portion of shoreline):

- Reach 9 is 18% armoured, 82% natural.
- Shore protection is sporadic throughout the reach and limited to private property infrastructure. Most structures are boulder revetments or concrete rubble revetments and concrete seawalls, most of which are ad-hoc and in poor condition.
- Significant variability in armoured vs. natural shoreline, level of design, type of shore protection and structure condition exists throughout the reach.
- A great deal of flanking exists throughout the region where an unprotected property has continued to erode adjacent to a protected or partially protected property.
- Shore protection throughout Popham Bay is particularly vulnerable to being overtopped due to the bedrock shelves that are prevalent in the nearshore and the extremely low land elevation.
- Tolerance for additional shoreline armouring (low/**medium**/high):

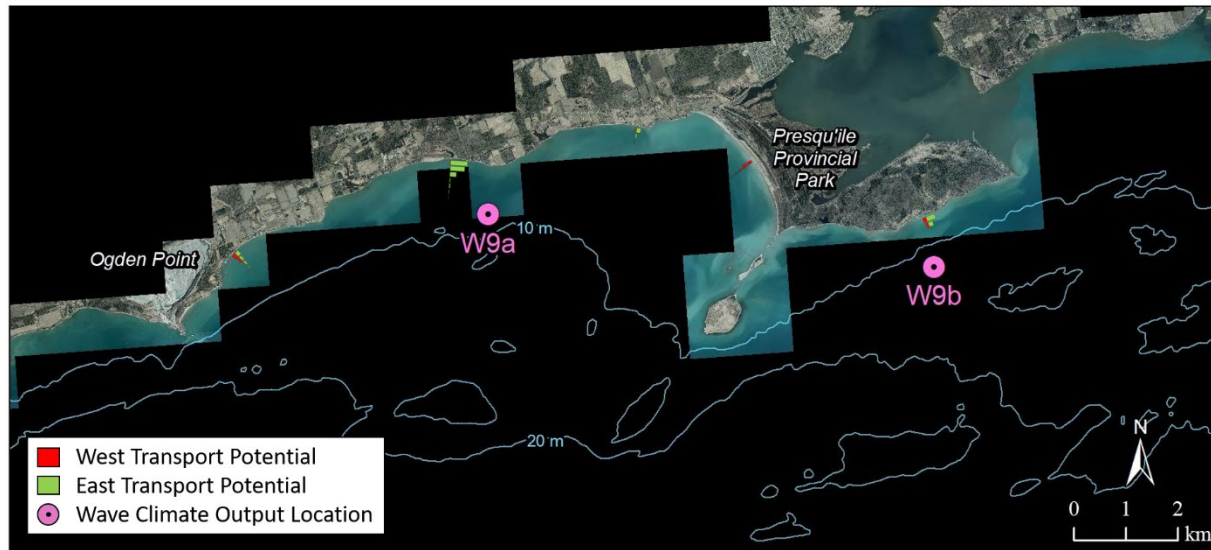
Sediment Supply and Longshore Sediment Transport

- Longshore sediment transport is predominantly from west to east in Reach 9 with a net transport potential of 30,000 to 50,000 m³/year.
- Sediment transport is especially limited at the west end of the reach in the Victoria Beach region, where the net transport potential is virtually zero. This region appears to feature a sediment sink offshore, however the shoreline itself is highly erosive.
- East of Victoria Beach sediment transport occurs from west to east, but the actual transport is likely significantly lower than the potential transport for the region due to a lack of sediment supply.
