# LOWER TRENT CONSERVATION

## NOTICE OF REGULAR MEETING OF THE LOWER TRENT CONSERVATION BOARD OF DIRECTORS

Staff recommends that the Flood and Erosion Control Structures Operations and Maintenance Manual be approved and adopted by the Board of Directors.

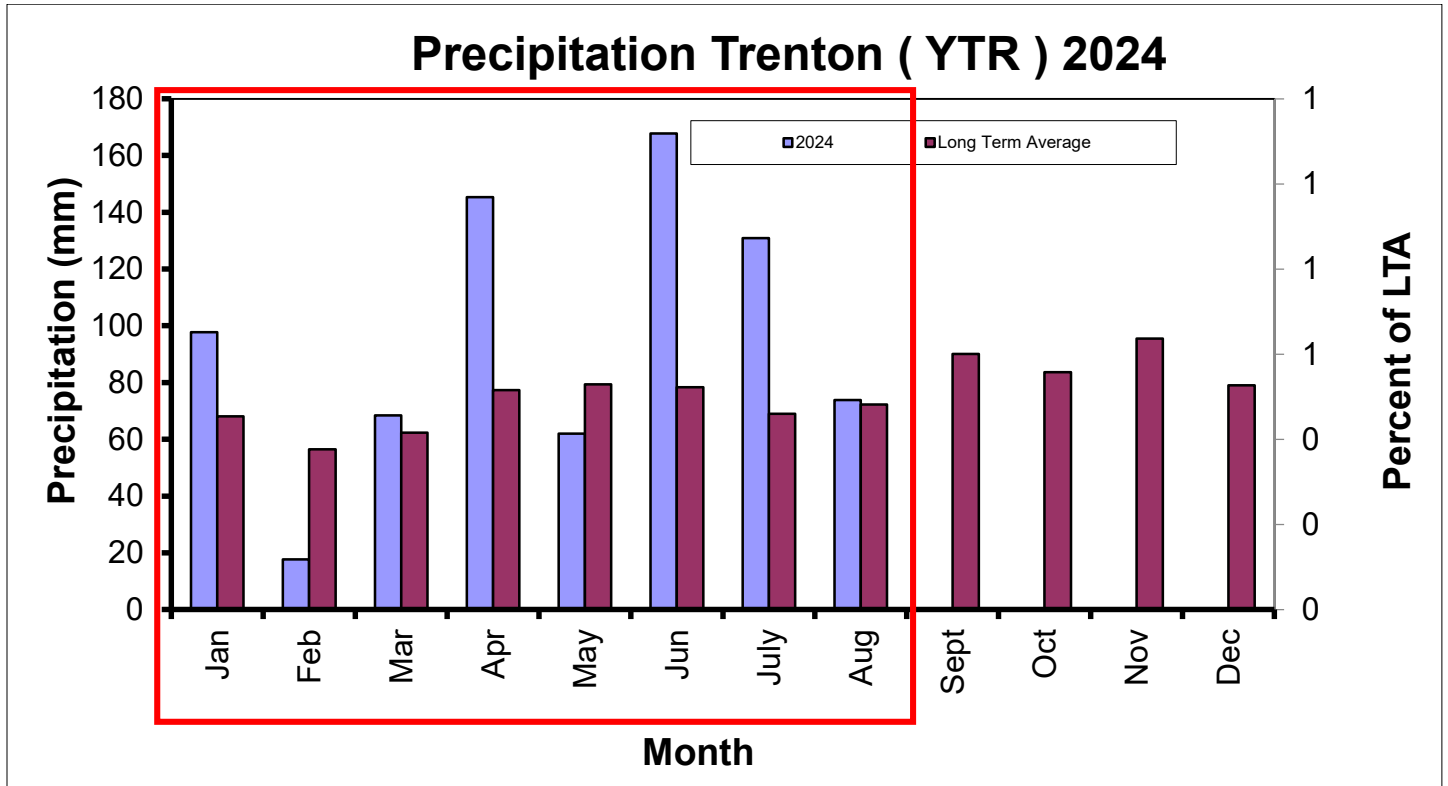
Table 2. Observed Monthly Precipitation (mm) in 2024 compared to the monthly long-term average.

Observed precipitation volumes were far greater than the monthly long-term average for the month of July (see Table 2). So far, the observed precipitation for the month of August slightly exceeded the long-term average. Although, we are still in the month of August, this has been the third month in a row where we have seen total precipitation volumes that have exceeded the long-term averages.

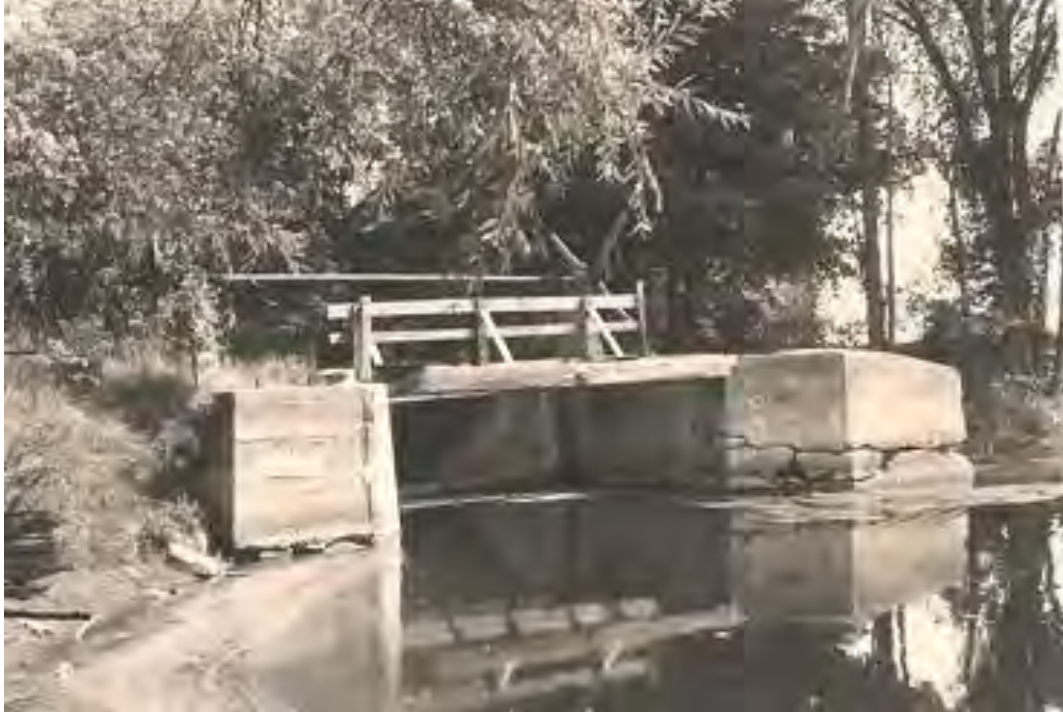
**Figure 5: Photo of "Old" Warkworth Dam – 1967**

In July of 1966 the Township of Percy contracted Totten Sims Hubicki and Associates (TSH) to undertake a Preliminary Engineering Report regarding the two dams and two ponds in the Police Village of Warkworth. The Township had recently come into ownership of this property that was located on both sides of County Road 25 and was planning to create a park for the Centennial Park Project for the Township of Percy. The pond was originally a mill pond providing power for the adjacent mill property but since the mill was now electrified, this power source was not required. The reference to two dams refers to the two spillways from the mill pond – the main spillway (located in the northeast corner of the pond, approximately in the same location as the current dam) and an emergency by-pass (secondary) spillway that discharged to the south, crossing under Mill Street and George Street before reconnecting with Burnley Creek (also known as Mill Creek). There were at least two houses constructed over this spillway by-pass channel as well.

The Preliminary Engineering Report submitted in January 1967 provided general hydrology for the area and calculated design flows and capacity flows for the existing structures and proposed improvements for the main spillway. The engineering report was also to look at the feasibility of removing the emergency spillway. The proposed main dam upgrades and closure of the emergency spillway was proposed to cost \$52,000.

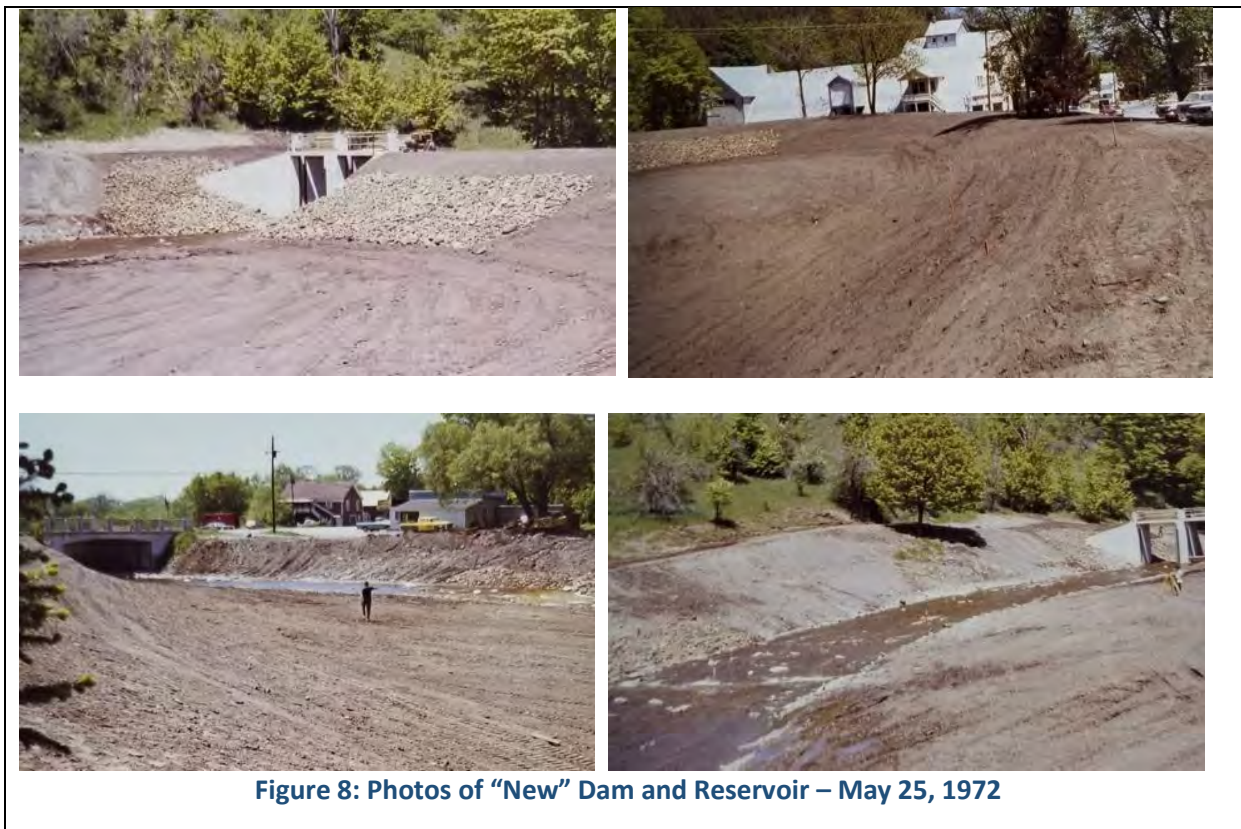
The project construction began in September 1971 and was completed in the summer of 1972 with an official opening of the new dam and reservoir on September 13, 1972. The new dam, with two 17-foot (5.2 metre) wide spillways replaces the old 19-foot (5.8 metre) wide spillway and the by-pass channel. The new spillway increased the discharge capacity from 3000 cfs (cubic feet per second) (85 cms – cubic metres per second) to 5200 cfs (147 cms) with stoplogs removed, and a 24-inch (0.6-metre) low flow pipe ensured a controlled downstream flow at all times. Photos of the “new” dam and reservoir from May 25, 1972 are shown below.

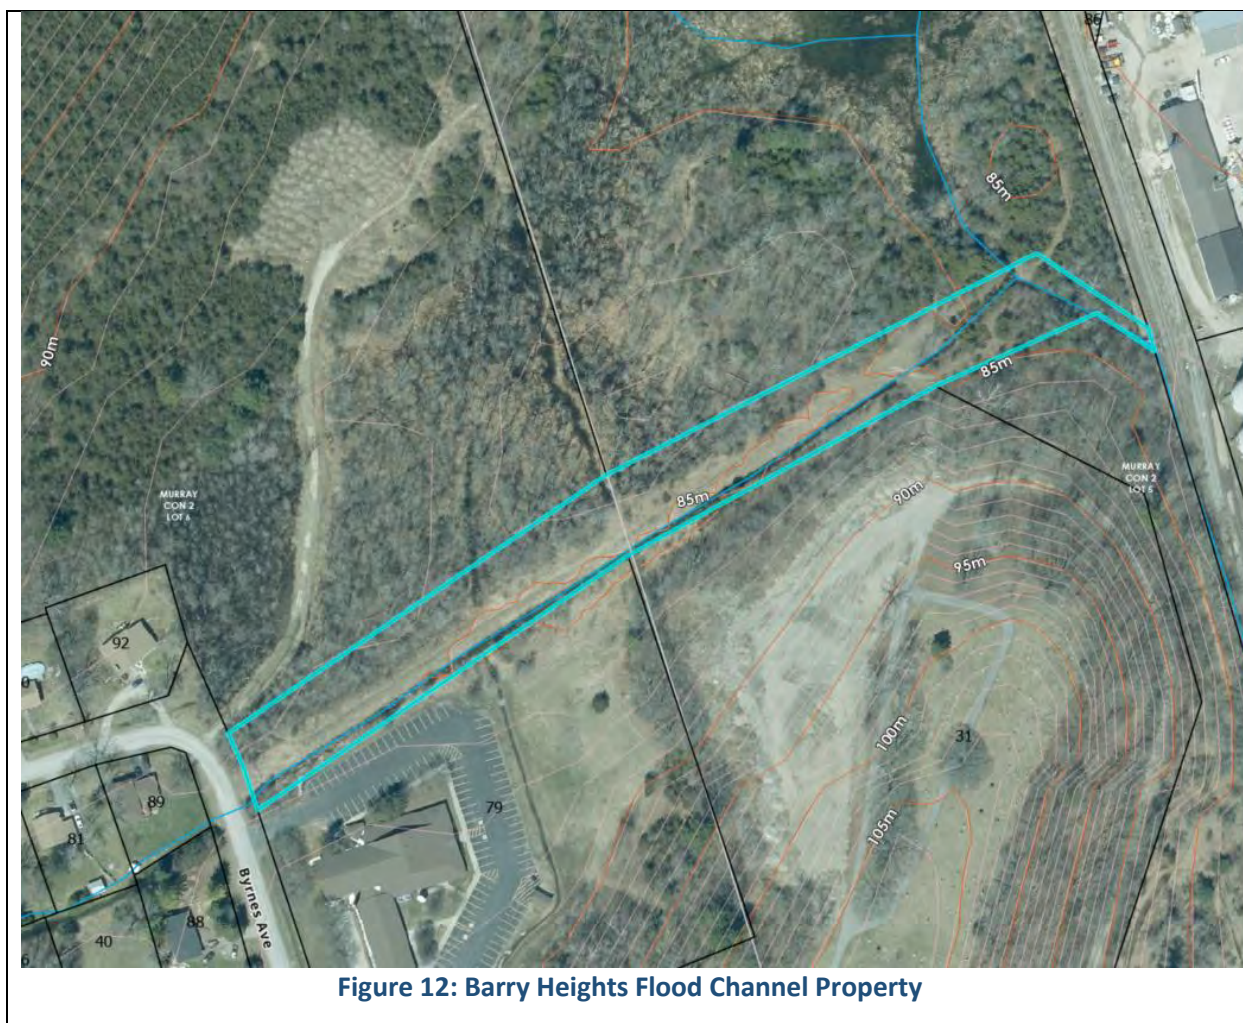
**Figure 12: Barry Heights Flood Channel Property**

In 2013 LTC was circulated on a letter from Raymond Kaufmann, Lawyer for the Estates of Hubert & Cecely Mansfield, concerning the easements over lands owned by the Mansfield Estate in favour of LTC and over lands owned by LTC in favour of the Mansfields. In the 1980's as part of the Barry Heights flood reduction channel works these instruments/easements were registered on title to allow either party to ingress/egress over the others lands. It appears that in 2005 when a new system of electronic land registration was implemented by the Province these old instruments/easements were not transferred due to a change in the way the parties would need to be described in the easement (Dominant vs Servient). Status of these easements should be further investigated if access issues arise.

The original plan was to acquire access across two properties (Scott and Mansfield) and drainage easement through Mansfield lands. Project was delayed in 1981 due to issues with access and ownership and eventually LTC acquired lands for the drainage works rather than easements for the work. Easement across Mansfield lands was obtained while providing Mansfield easement access through LTC lands to his property to the east. Easements and deeds are filed with LTC land information.

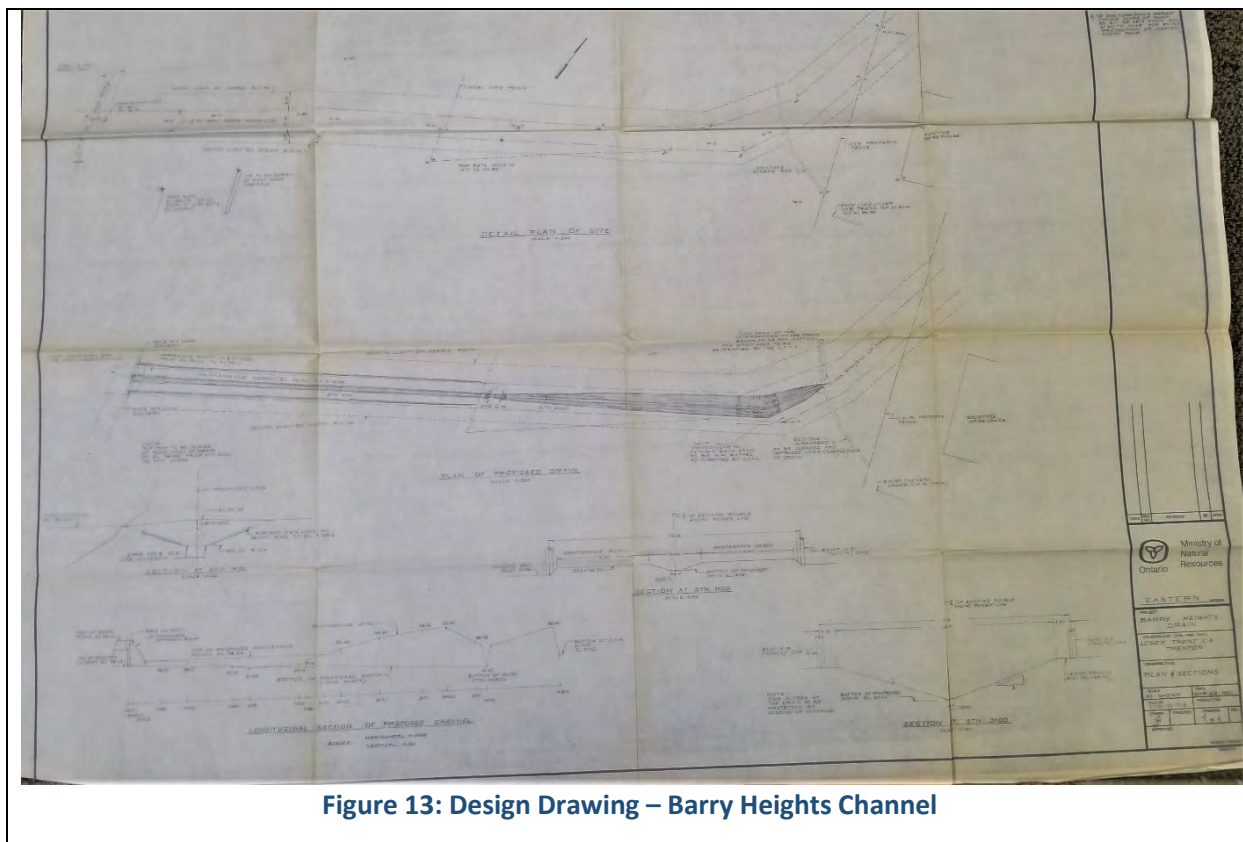
**Figure 13: Design Drawing – Barry Heights Channel**

Because of the very shallow slope of this channel, the velocities of water are low and over time sediment deposition and vegetation growth will hinder flow in the channel and it needs to be cleaned out. The first documented clean out was in 2002 and the channel was again cleaned out in 2015. There is a note in the 2002 documentation that says it has been about 10 years since the last cleanout but no documentation of a cleanout circa 1992.

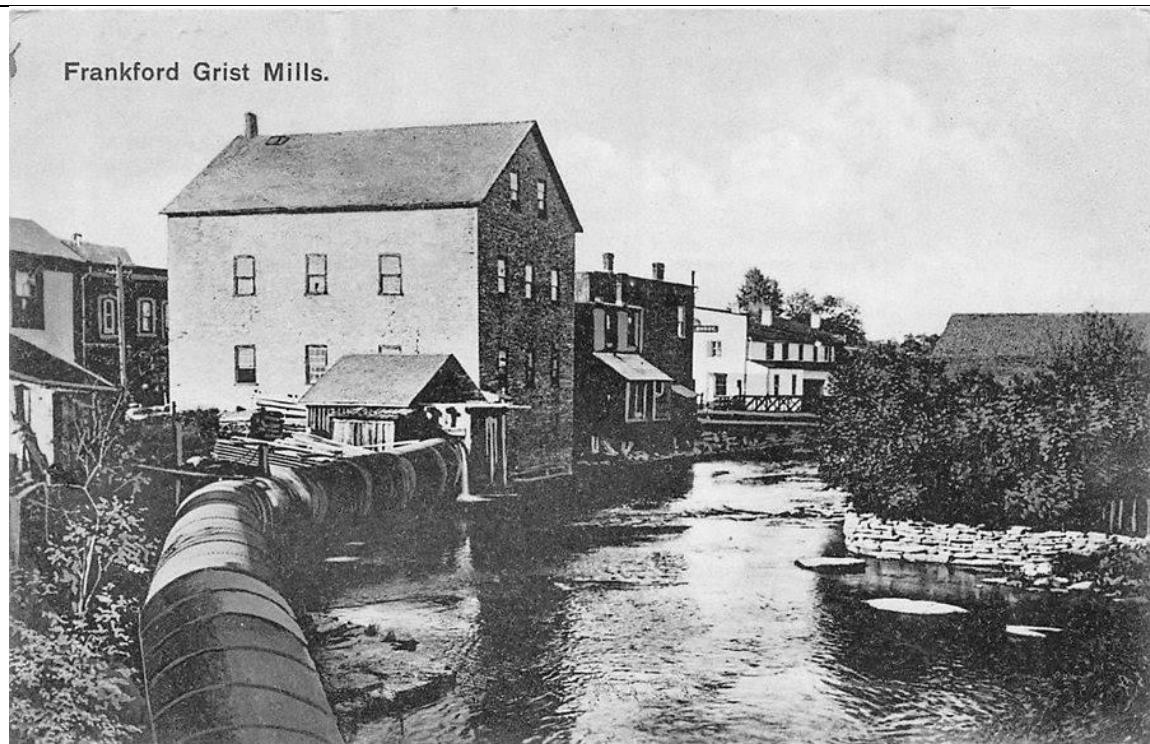
**Figure 15: View of the Old Mill with Flume Pipe in the Foreground**

The pipe is described as being 58 metres in length and 2 metres in diameter. In 1992 proposals were sought from various engineering consultants to assess the condition of the pipe and make recommendations for any required remedial works along with drawings, tender documents and construction supervision. In the proposal request letter noted that decay and shifting of the concrete pipe support were noted along with erosion behind the pipe. A response from the Village of Frankford noted that they did not have the funds to support this remedial works project and there are no further notes in the file.

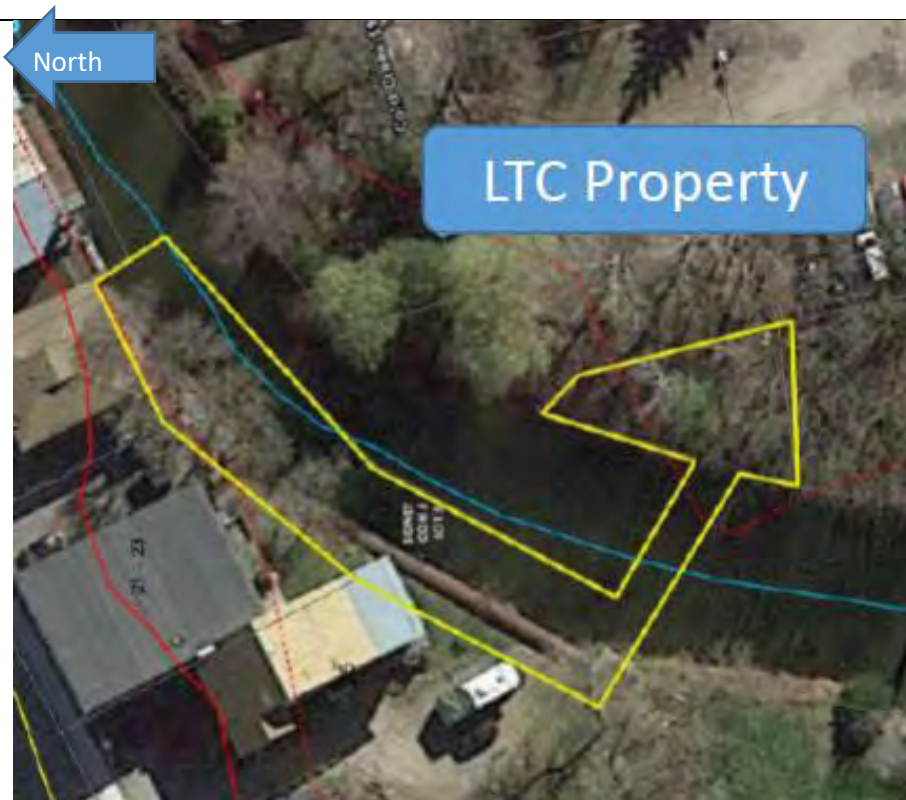
Figure 16: LTC Property with Pipe for Erosion Control

In 2021 LTC undertook removal of a number of trees (mostly Manitoba Maple/Box Elder Trees) that were growing on the landward side of the pipe. Although these trees were providing shade for the adjacent landowners, portions of the trees were close enough to cause damage to the buildings and were determined to be hazard trees. There was also concern about the tree roots causing shifting of the pipe.

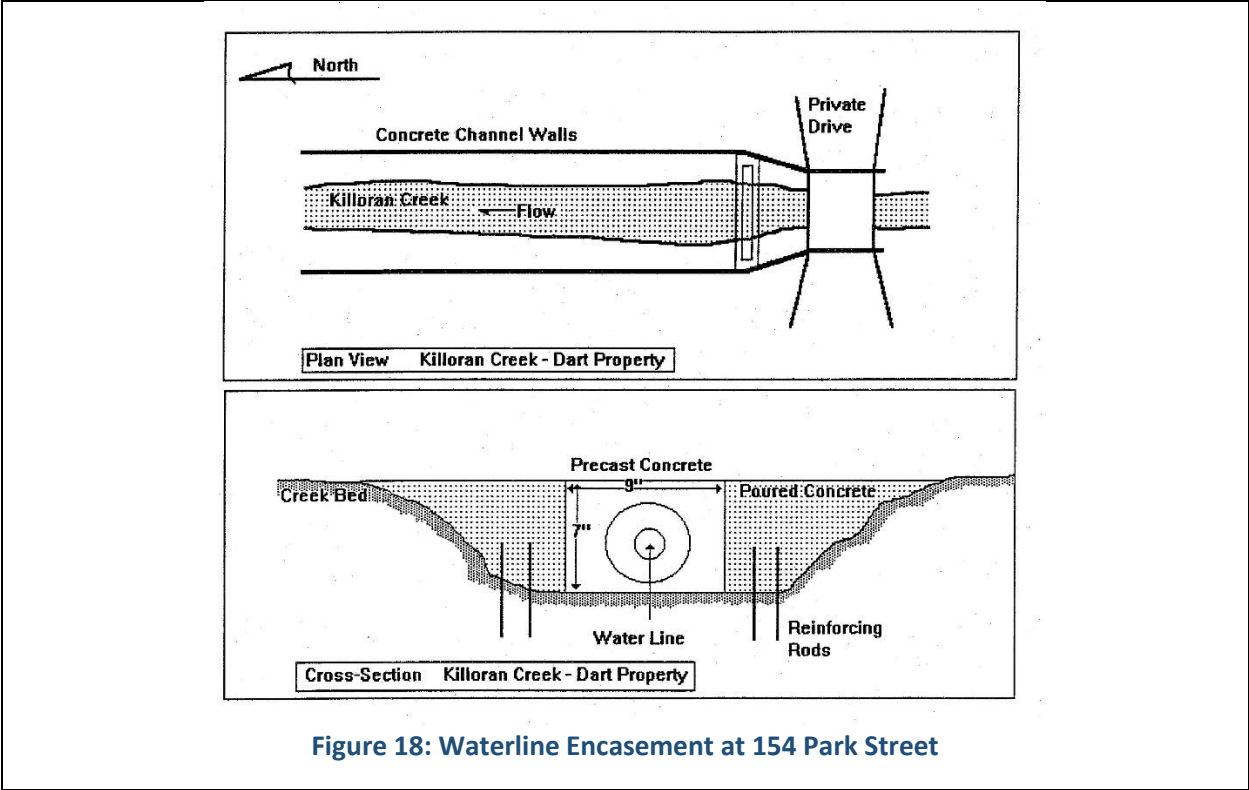
Figure 18: Waterline Encasement at 154 Park Street

In 1993 there was erosion downstream of the driveway crossing at 154 Park Street that exposed the municipal water supply line that was under the creek bed. LTRCA applied to the province for a work permit to encase the waterline in concrete and also pour concrete apron upstream and downstream to prevent further erosion and undermining.

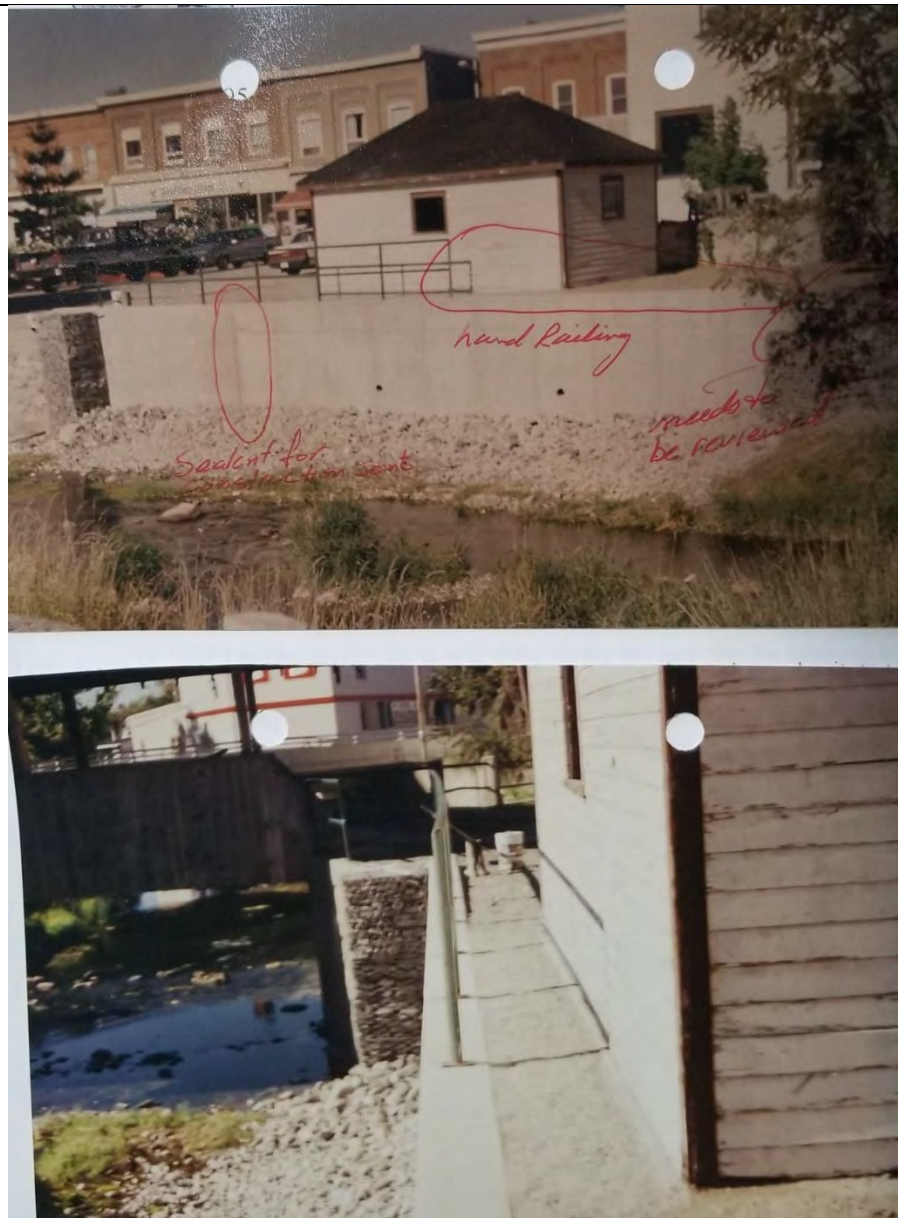
**Figure 30: Finished Concrete Retaining Wall – 1995**

In the end a concrete retaining wall was selected and the garage was moved westward from its original position. In EGA's letter (October 3, 1995), the following points were noted: concrete wall was 1 metre short on east end so gabion extension was constructed to fill the void; concrete wall was higher than designed so small retaining wall may be required at east end and property was infilled more than expected; because of the movement of the garage, the hand railing did not extend easterly enough and needed to be extended.; and an as-built survey was recommended. Photos of the finished wall are shown below with areas noted above circled in red.

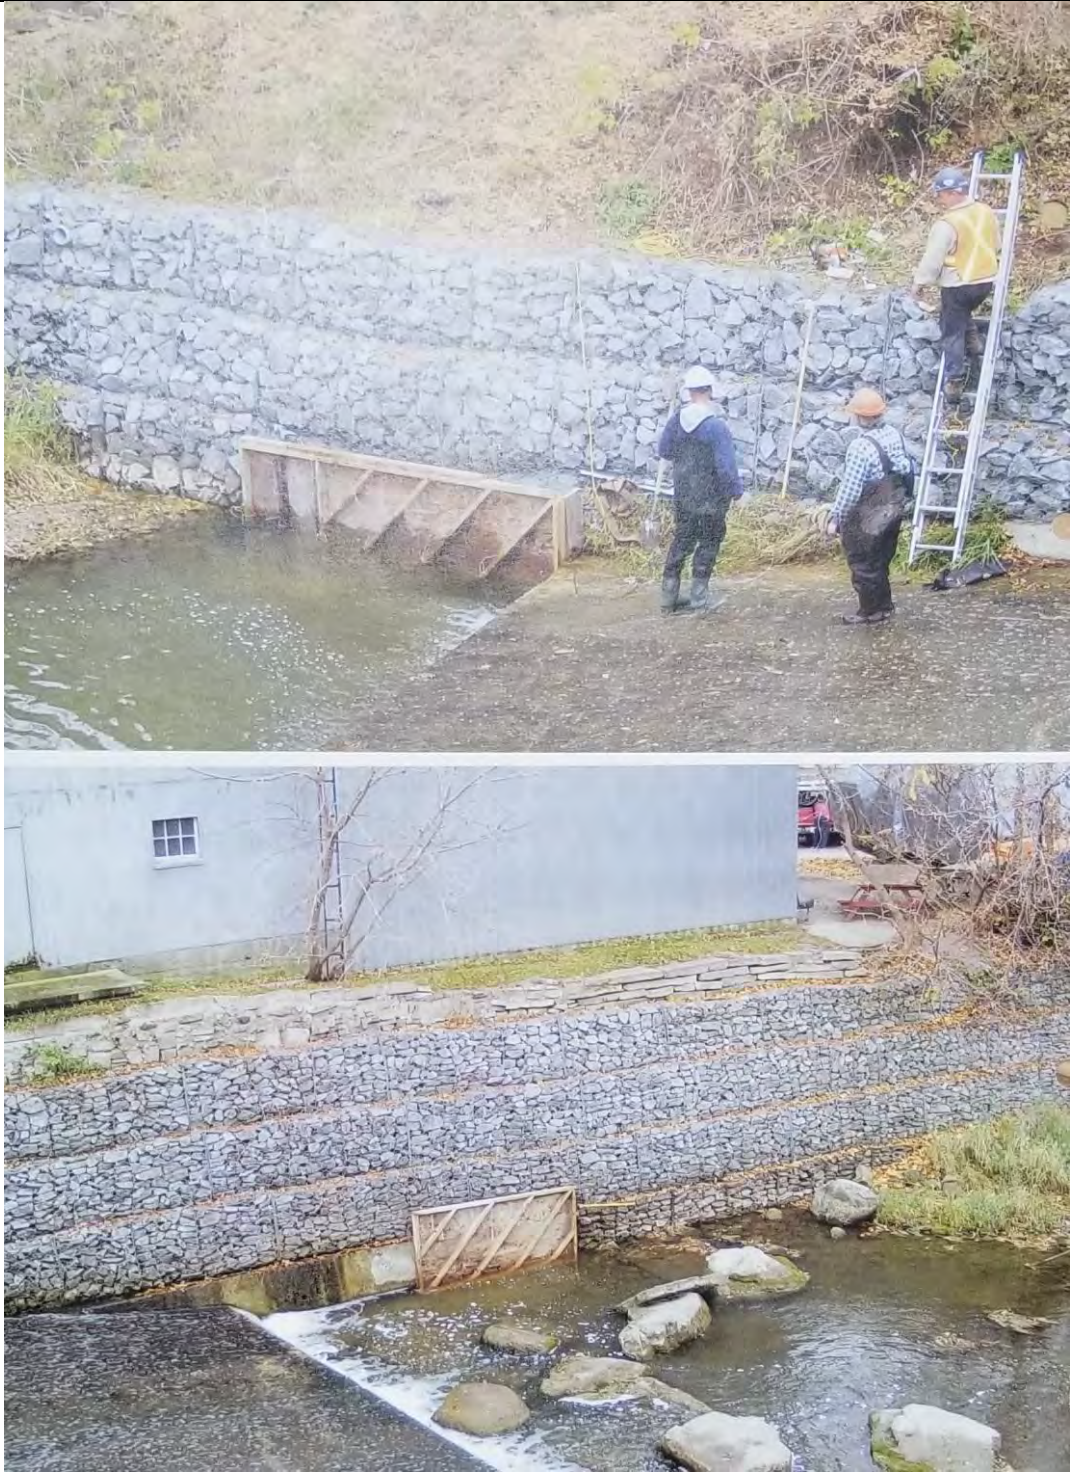
Figure 33: Concrete work for failing gabions in 2007

LTC Permit and MNRF Work Permit were obtained prior to the work being completed by Eastern Restoration & Masonry Belleville Ltd. The cost of \$17,051.70 was shared 50/50 between the Township and LTC.

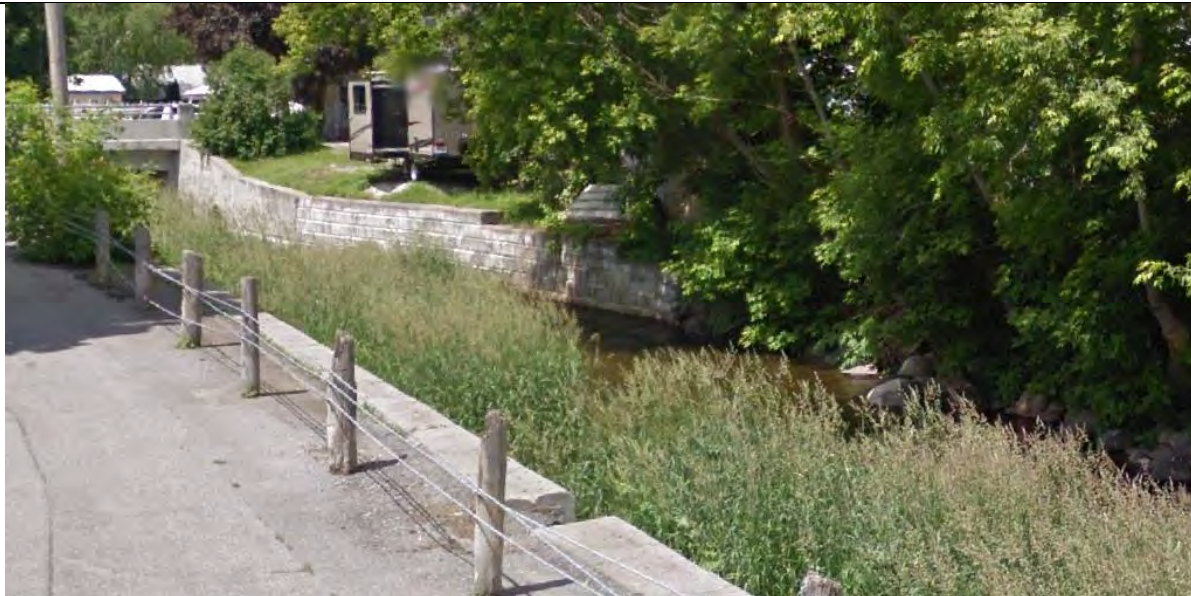
**Figure 39: North Bank DuraHold retaining wall transition to river rock protection**

The channel improvements began at the Simpson Street Bridge and the entire section between the Simpson Street Bridge and the Pellissier Street Bridge was included in the flood control works, which included the sewer realignment and installation of a sanitary pumping station, stream deepening and realignment, DuraHold retaining wall installation along the entire south bank and on the western-most property along the north bank. The remainder of the north bank was protected by a river rock revetment style erosion protection work. The figure below shows the DuraHold retaining wall portion along the north bank and the transition to the river stone protection. The south bank retaining wall is also evident with the cut-outs in the capstones for roadside drainage.

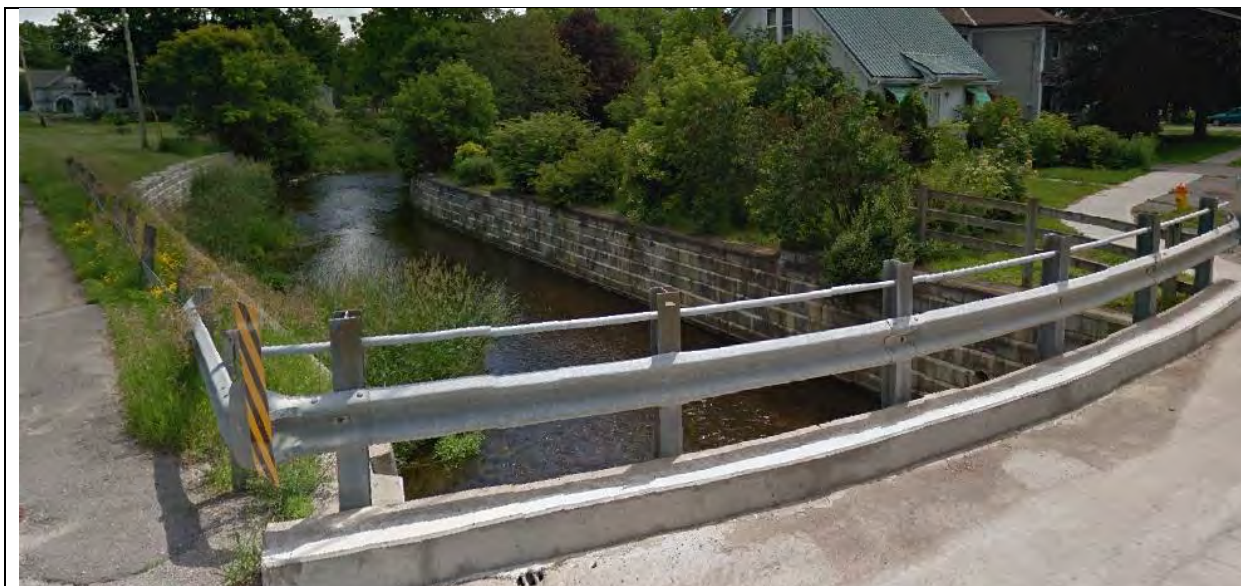
**Figure 41: Trout Creek looking eastward from Pellissier Street Bridge**

The DuraHold retaining wall was continued from the Pellissier Street Bridge on both the north and south banks of Trout Creek as it flowed eastward but the retaining wall transitions to a rock revetment style protection of the cut-back banks as the creek turns southward. This rock protected bank continues southward to the Balaclava Street Bridge.

The figure below shows the downstream end of the DuraHold retaining wall on both the north and south banks of Trout Creek and the transition to river rock revetment protections as the creek turns southward.

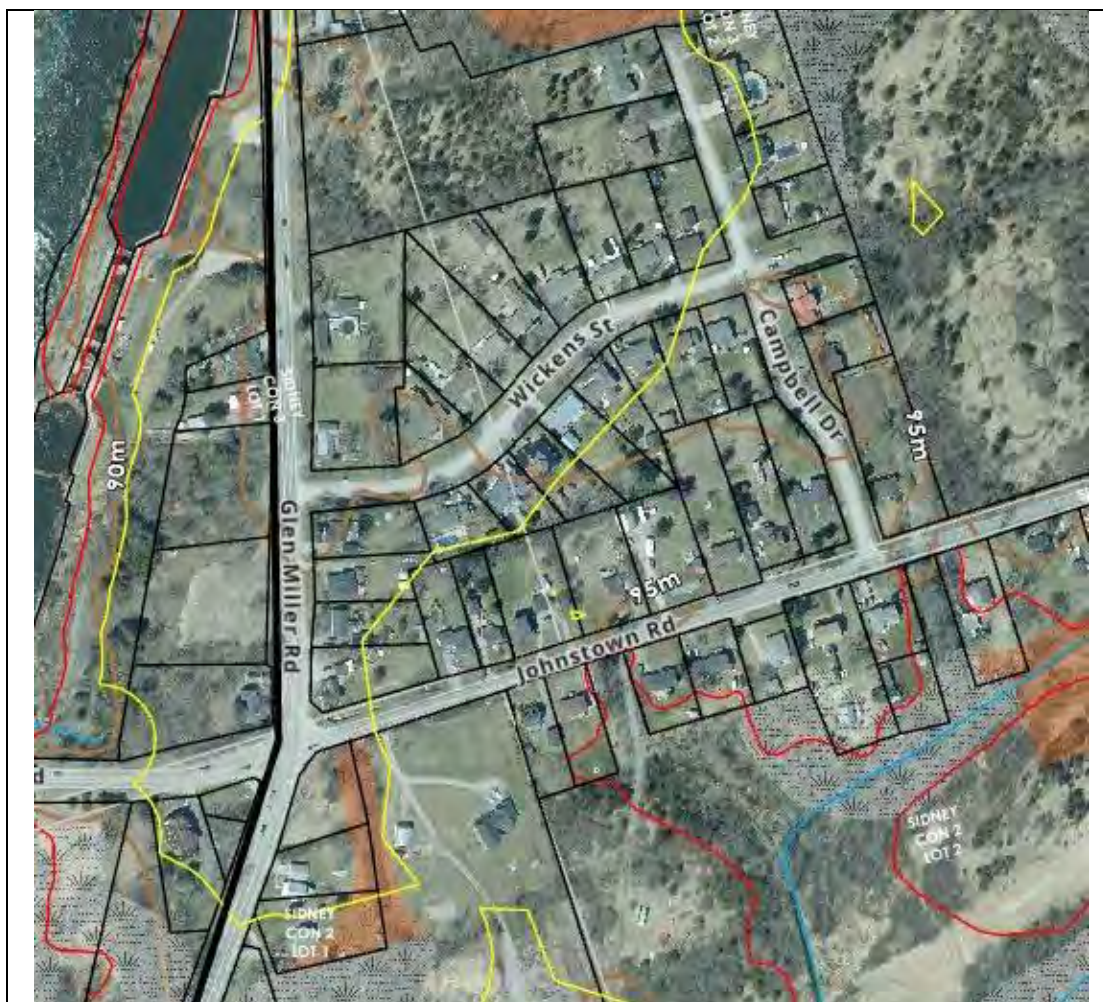
**Figure 46: Munroe Estates on Johnstown Road**

The area of the Munroe Estates Subdivision along Johnstown Road is shown below. This area is referenced as Site C in the Preliminary Engineering Study by CCL and it experienced regular poor drainage and flooding during the 1980 flood event.

The conclusion in the 1983 Preliminary Engineering report by CCL explains the situation at the Munroe Estates area: *“Based on the hydraulic analysis, and on the historic records, Monroes’ Estates (Site C) are being subjected to a potential flood hazard. The flooding here is attributed to both the backwater from Glen Miller Creek and from the culverts located within the subdivision. The proposed improvements which include an earth berm and realignment of the Monroe Estates storm drainage outlet would provide Regional Storm protection from the backwater from Glen Miller Creek.”* This flood damage area was prioritized third indicating the other two projects were more urgent. The proposed berm and swale upgrades are shown in the figure below.

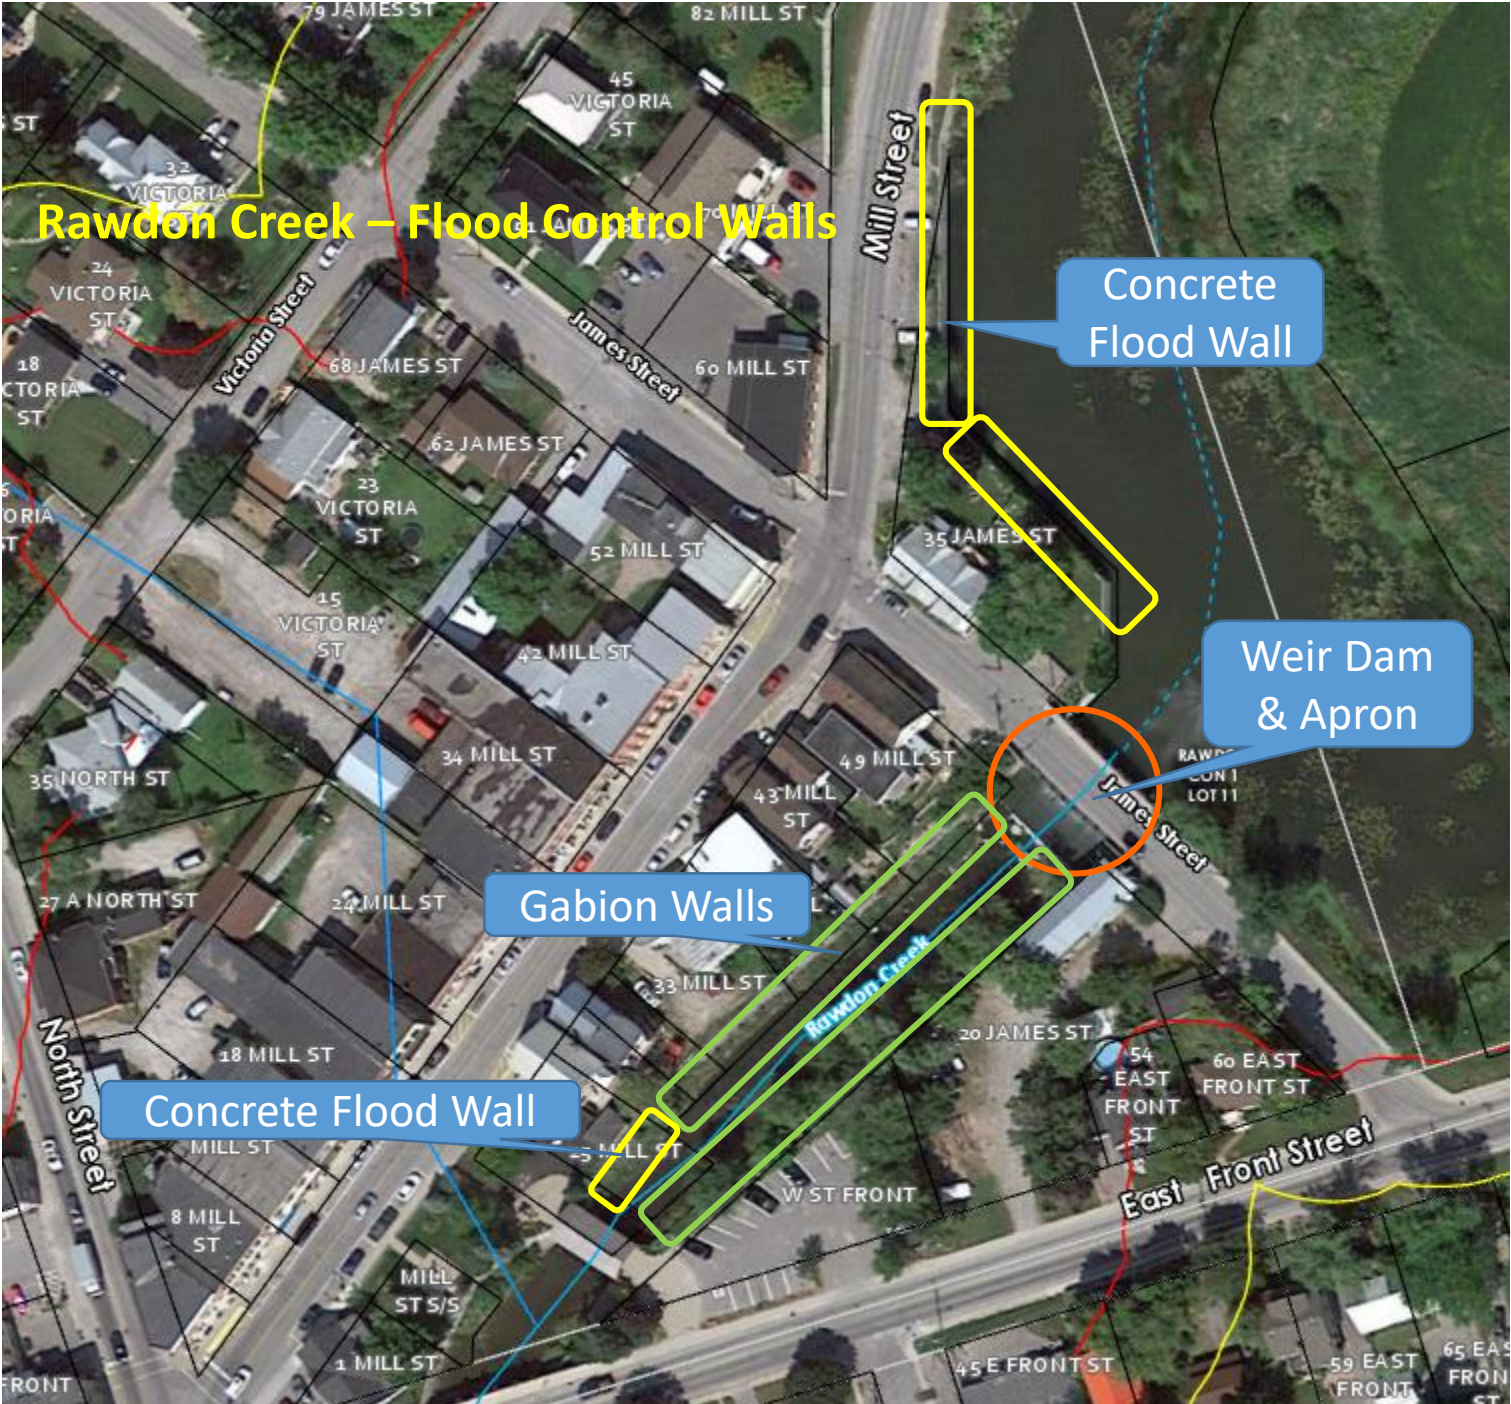
**Rawdon Creek – Flood Control Walls**

Concrete Flood Wall
